Low Velocity Impact and Internal Pressure Behaviors of Unaged E-Glass and S-Glass/Epoxy Composite Elbow Pipe Joints

Abstract: This experimental analysis studies the consequences of impact loading on the impact performance and monotonic burst pressure on the level of leakage after impact of E- and S-glass/epoxy composite pipe joints. First, impact tests with three dissimilar energy points (10, 12.5, and 15 J) were applied on composite elbow pipe joints at room temperature, followed by burst pressure tests. Scanning electron microscopy pictures were taken, and the relationship between levels of impact energy on the pipe joints with burst strength was recognized. The results of proposed S-glass/epoxy composite elbow pipe joints were more prominent when were matched with that of a reference specimen, an E-glass/epoxy composite elbow pipe joint. This research proposes a new perspective that impact strength depends upon the increase in time of impact and type of material used. DOI: [10.1061/\(ASCE\)PS.1949-1204.0000493](https://doi.org/10.1061/(ASCE)PS.1949-1204.0000493). © 2020 American Society of Civil Engineers.

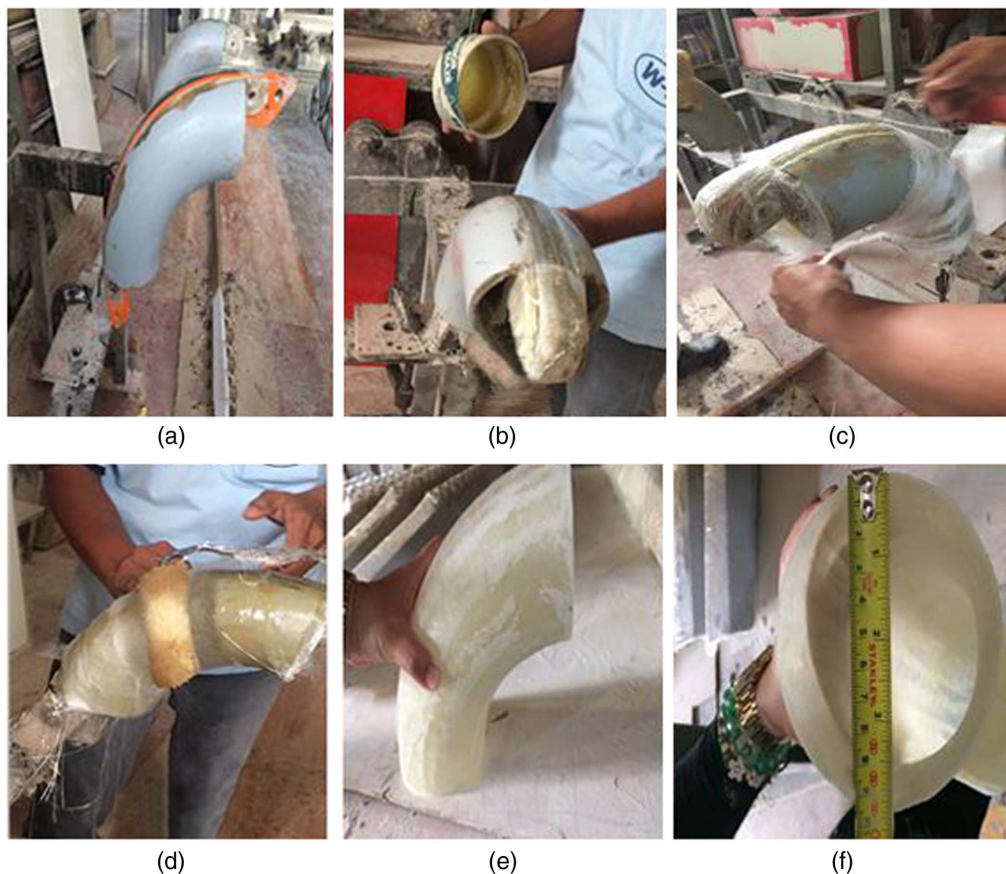
Fig. 1. Fabrication process of E-glass and S-glass elbow joint: (a) mold preparation; (b) applying wax; (c) applying S- and E-mats around the mold; (d) applying resin; (e) completion; and (f) measurement.

Glass epoxy elbow pipe joints were made manufactured by a hand lay-up process as per ASTM D5685 (ASTM 2011) standard, which shows the typical construction of fiber glass (glass-fiber-reinforced thermosetting resin) pressure pipe fittings by hand lay-up equipment. One layer full wrap of each E-glass and S-glass roving as shown in Fig. 1 is used in the preparation of the specimens. An inner radius of 100 mm, outer radius of 101.75 mm, and finally radius of curvature of $R = 1.5D$ were used as the dimensions for the fabrication of elbow joints.

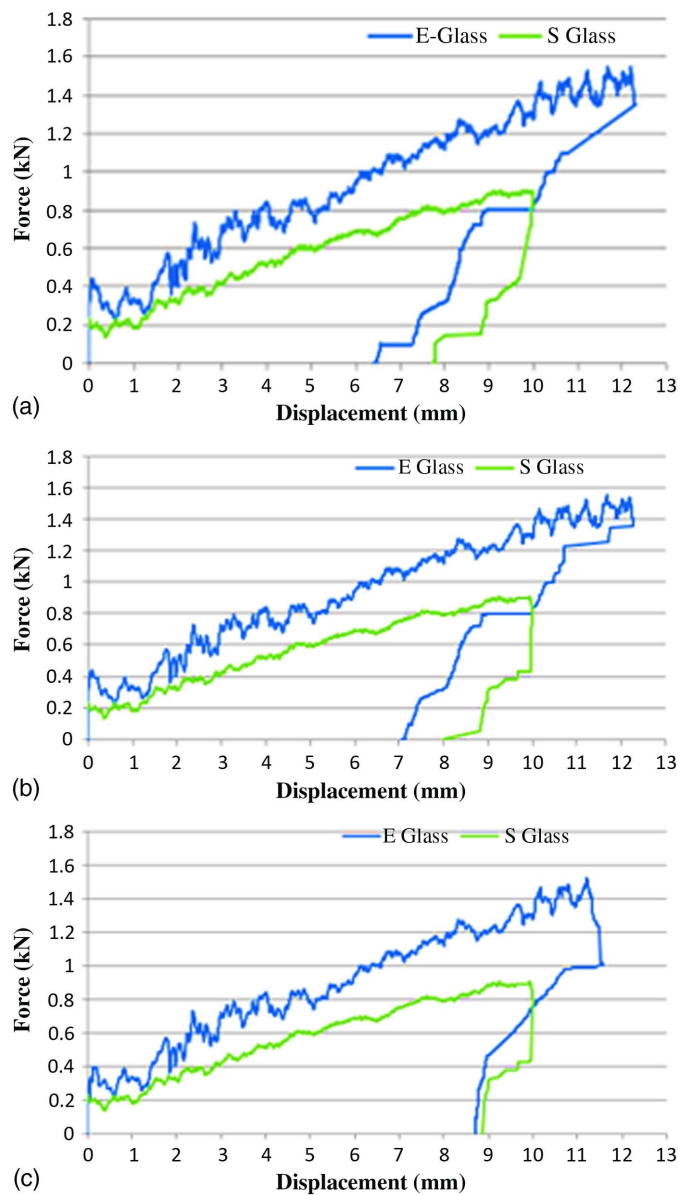
Fig. 7. Force-displacement curves of impacted elbow pipe joints: (a) 10 J; (b) 12.5 J; and (c) 15 J.

Once the impact energy increased, the highest contact force on the elbow joints was noted, and the importance of impact energy applied is evidently observed to rise in the graphs. Circumferential expansion for the specimens below the influence of different impacts have been noted from Fig. 7, and variations were detected from the graphs that show the damage formed on the elbow joint. The fact that more variations were observed on the graph of the

In the force-displacement curves, the E-glass elbow joint showed a considerable increase in level of force in each impact energy, unlike the of S-glass elbow joint, but when it comes in the case of displacement at the final deformation, the S-glass elbow joint showed more interest rather than the E-glass elbow joint. This means that the S-glass elbow joint has a more elastic nature when impacted by a force than the E-glass. In addition, one can predict that the Poisson's ratio of the proposed S-glass elbow joint would be higher compared with that of the E-glass elbow. In some cases, the impact force does not depend on the impact due to displacement, but this depends upon the type of material and matrix used.

The gradient of the force versus displacement curve is the bend-over inflexibility that can be justified, which can be noticed in Fig. 7. There are two distinct features or regimes found from each curve. The first feature can represent the primary indentation. When the contact force commences to curve the pipe joint layer, a minor

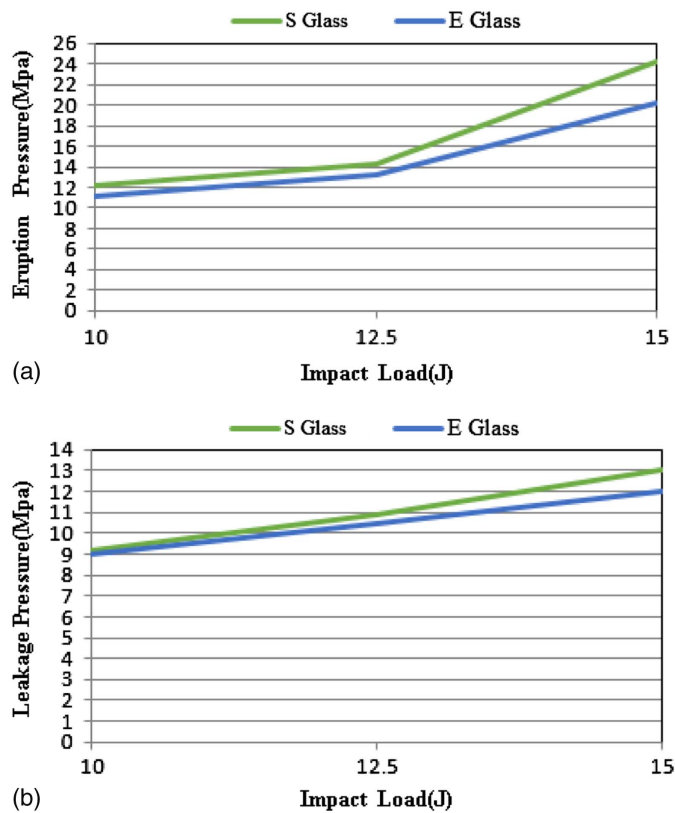
Fig. 11. Comparison between (a) leakage pressure-impact load; and (b) eruption pressure-impact load of E-glass and S-glass elbow pipe joints.

When performing internal burst pressure tests, three different failure approaches were observed: weepage, whitening, and eruption. Weepage failure was witnessed on the elbow pipe joint layer impacted by low energy. As soon the internal pressure escalated more, extra droplets were seen, and later, after considerable

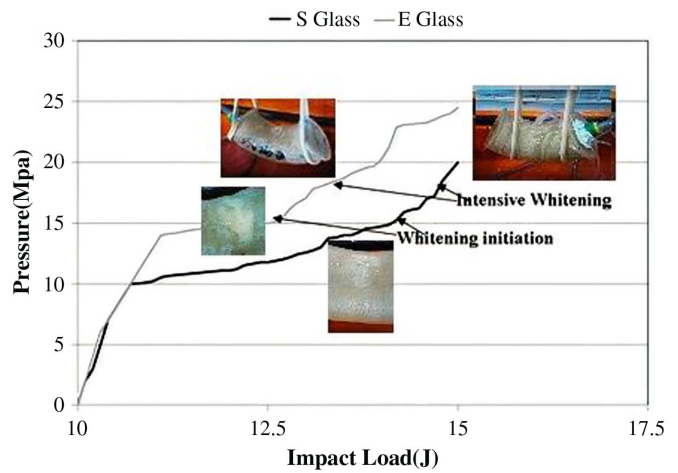
Fig. 12. Internal pressure-impact load for impacted E-glass and S-glass elbow pipe joints.

From Fig. 12, it can be noticed that the impact energy has a tendency to change the curve of the elbow pipe joints under the

influence of the different types of material (E-glass and S-glass) used. The purpose for this could be described as due to the presence of breaks on fiber as an outcome of the low-velocity impact. Influence of the fibers on the inelasticity of the elbow pipe joints is greater than that of the resin. Prior to the final failure, a pressure decline was detected in the case of elbow pipe joints with impact damages. In the case of sample with E-glass, the impact damage was more than that of S-glass specimen used; however, when the pressure reached 17.23 MPa, the damage was discovered to burst out. As for the sample made of S-glass fiber, it achieved whiteness and then after reaching the pressure of 18.1 MPa, protection in form of whitening developed over the damaged region of the sample, which attained its ultimate failure without any explosion. Finally, it indicates that strong protection occurred in S-glass sample and the sample has attained its ultimate failure state without any detonation when compared with the E-glass sample.
